# Manhole Inspection Summary

Manhole # S21KK\_034MH

Insp Date: **6/1/07 9:38 AM**

**Location** Address: **1903 FULTON AVE**

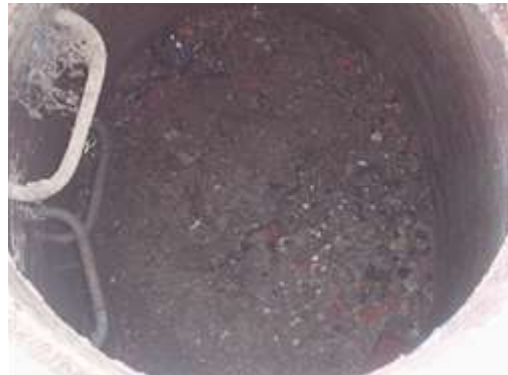
Top View

MAJOR DEBRIS ON BENCH

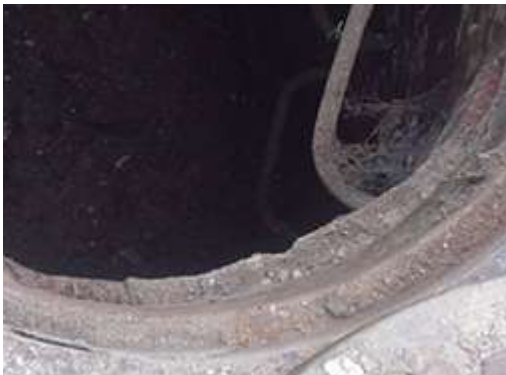
Defect 1

Offset: **1** (in.)

FRAME OFFSET

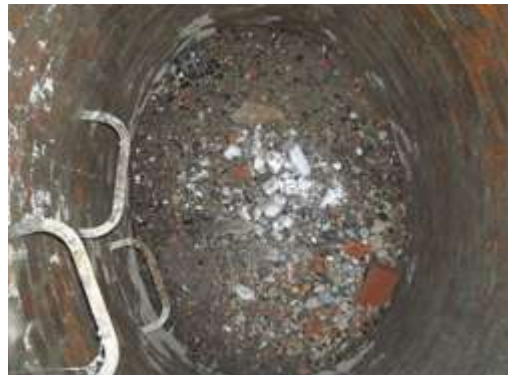
Defect 3

Condition: ☐ Sound ☐ Cracked ☐ Root Intrusion ☐ Deteriorated ☐ Leaks ☒ **Debris**

DEBRIS

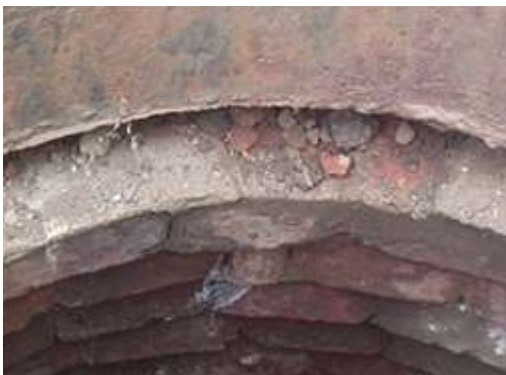
Defect 2

Condition: ☐ Sound ☐ Cracked ☐ Root Intrusion ☐ Loose Brick ☒ **Deteriorated**

CHIMNEY DETERIORATION

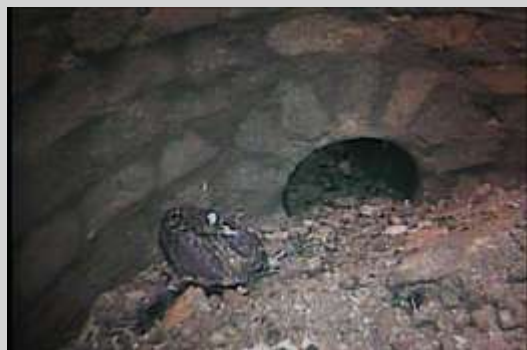
12 O'Clock Outflow

8 in. Circular Gravity Sewer  
Pipe Out @ 12 O'Clock

Deposits: ☐ None ☐ Mud ☐ Sludge ☒ **Debris** ☐ Grease

Silt Depth: **4** (in.) Deposits Extent: **Medium**
